NIOSH
Fire Fighter Fatality Investigation
and Prevention Program

Two Career Fire Fighters Die in a Rapid Fire Progression While Searching for Tenants—Ohio

Executive Summary

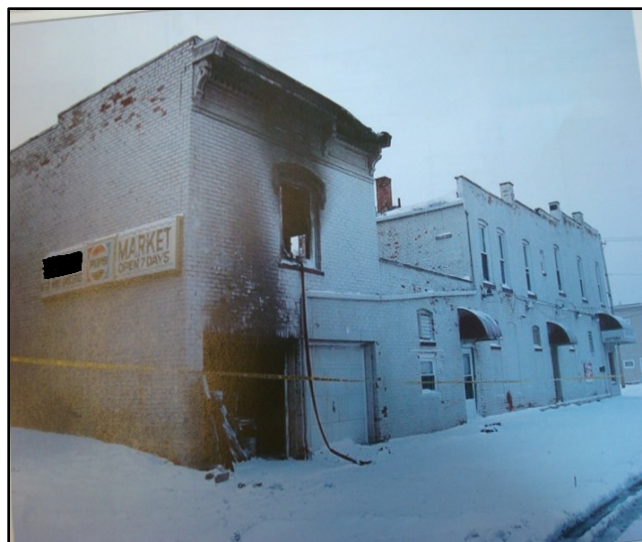
Engine 3 made entry into the window on the second floor.

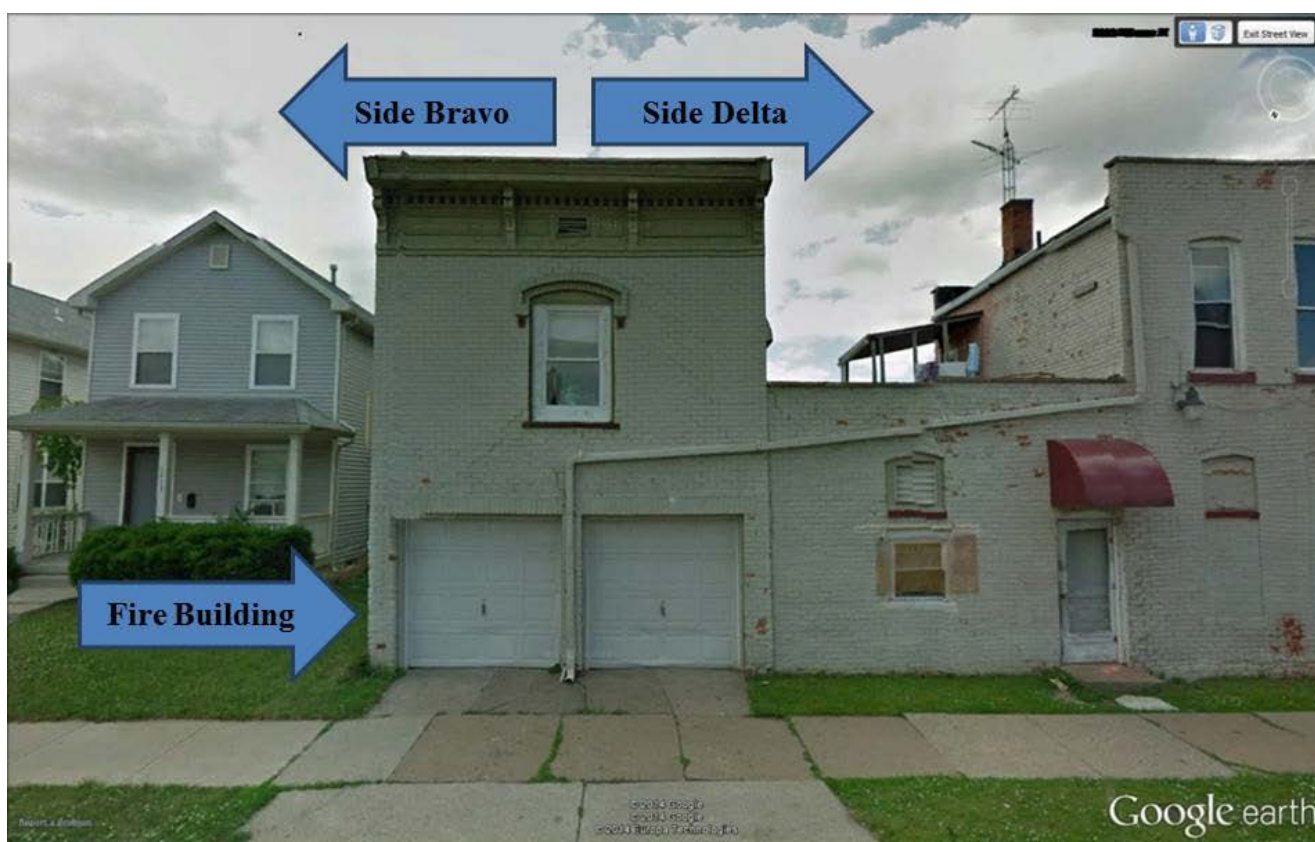
Photo 1. View of structure from Side Alpha. The first floor at the Alpha/Delta corner (to the right) was a small local market. The remainder of the structure is apartments, both first floor and second floor.
(Photo from Google Earth.)

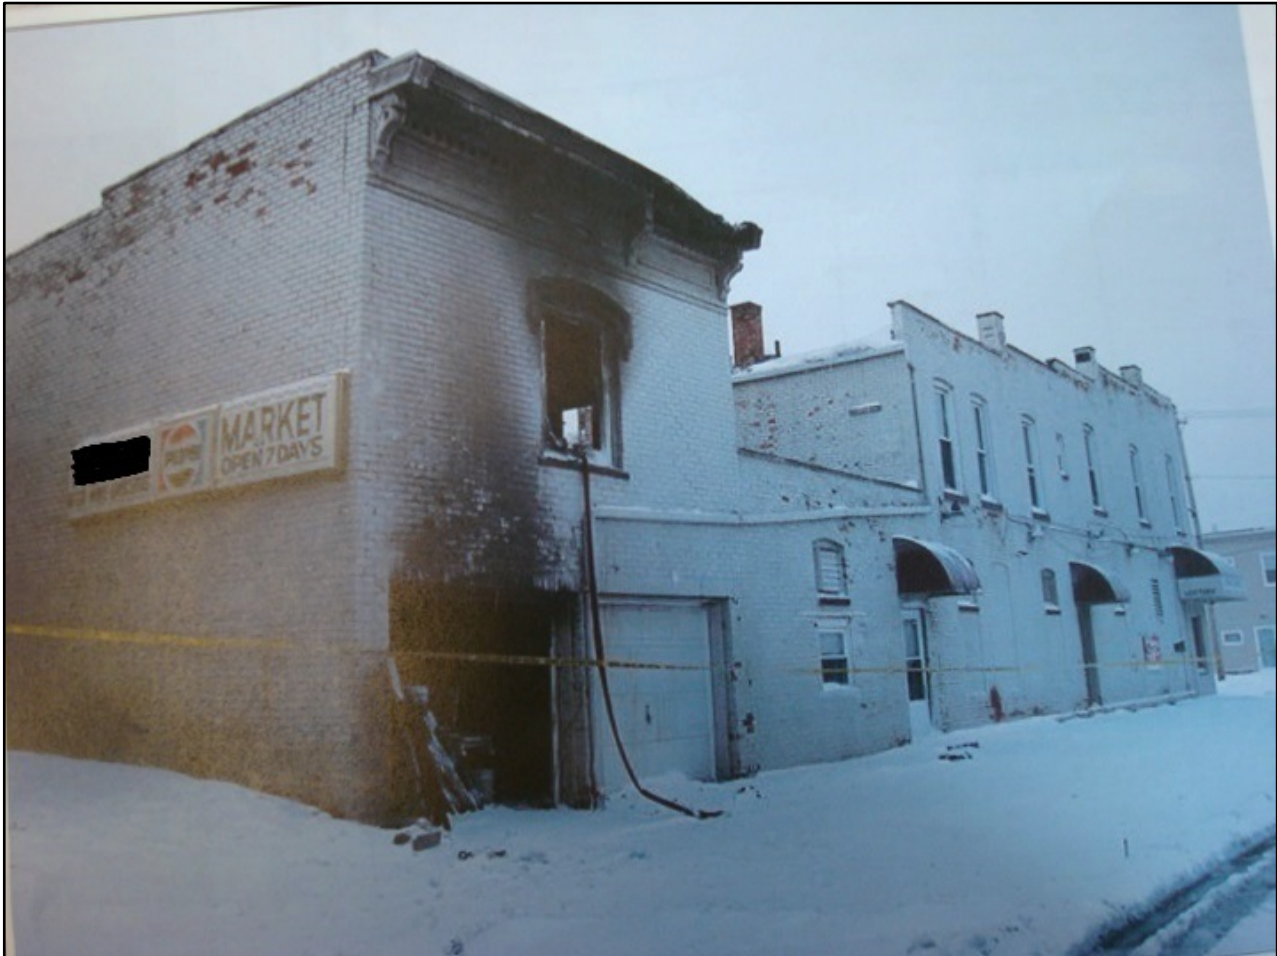
Photo 2. Side Alpha of the structure. Engine 3 entered the second-floor window upon arrival. Engine 13 opened the left garage door to initiate the initial search.
(NIOSH photo)

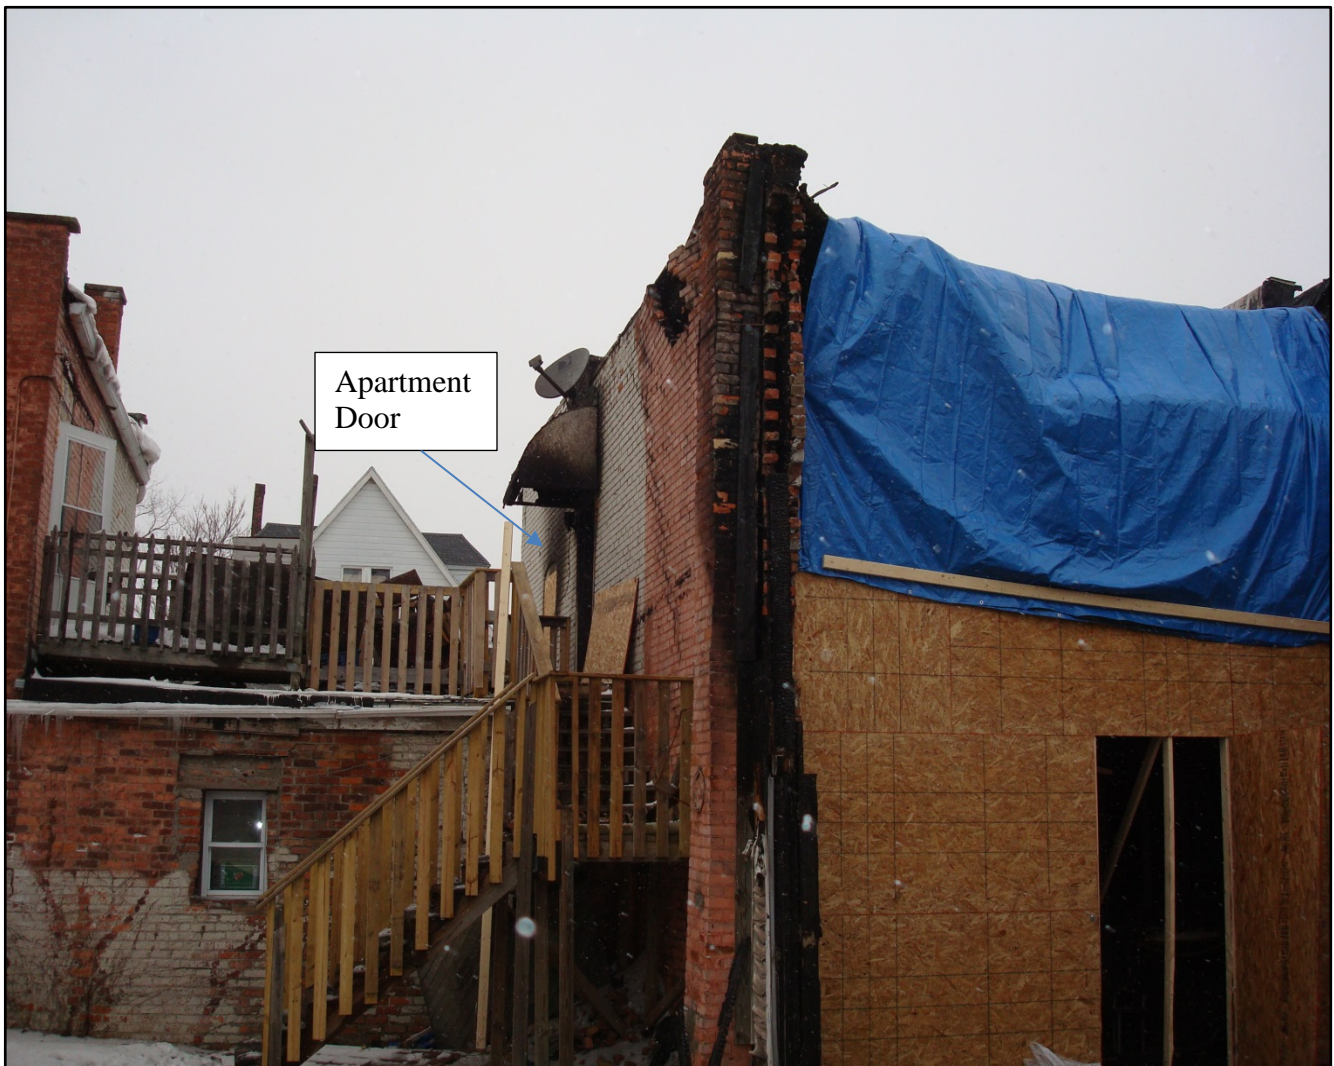
Photo 3. Exterior stairs to Side Delta man-door to second-floor apartment that Engine 6 entered.
(NIOSH Photo)

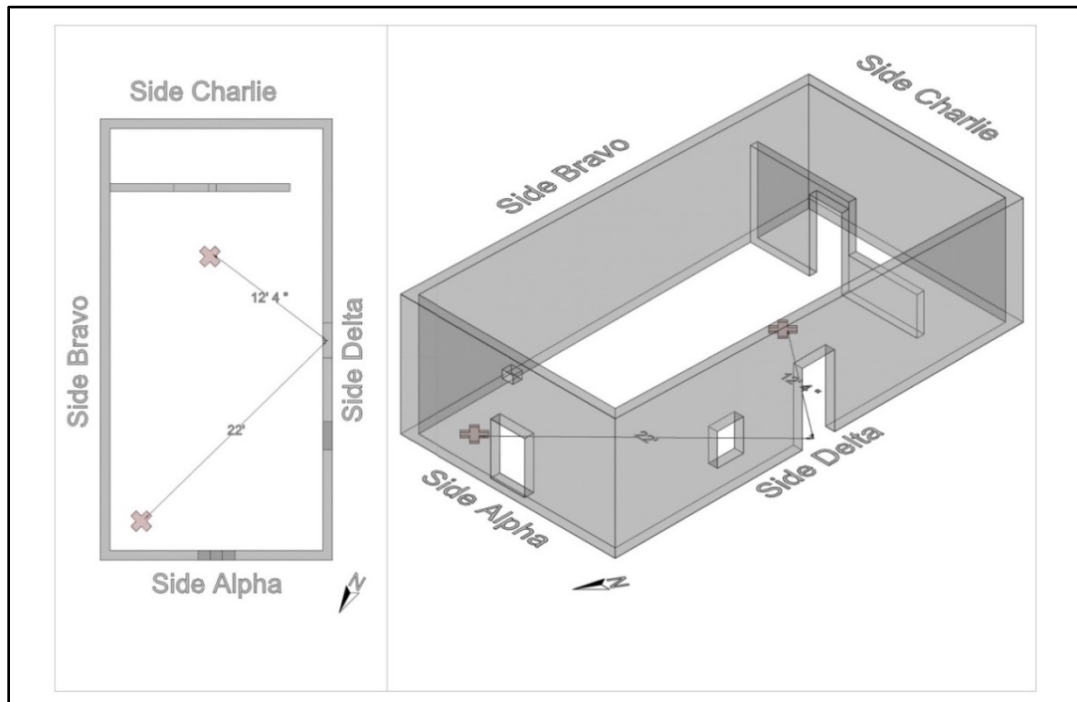
Diagram 5. Approximate locations of the two fallen fire fighters on the second floor of the fire structure. Fire fighter #1, which was located first, was found near the Alpha/Bravo corner. Fire fighter #2 was found closest to the Side Delta man door.
(Diagram courtesy of the city's Engineering Services.)
